Ice Factory, Grimsby Appraisal of Existing Structure by Alan Baxter & Associates LLP with Richard Griffiths Architects and KMCS (Cost Consultant) February 2010

1.0	Summary	1
2.0	Introduction	2
3.0	History of the Building and the Site	3
4.0	Geology	5
5.0	Form of Existing Structure	7
6.0	Obvious Defects in the Existing Structure	13
7.0	Proposals for Remedial Works to the Existing Structure	19
8.0	Proposed Alterations to the Structure	22
9.0	Next Stage	23
10.0	Existing Fabric, by Richard Griffiths Architects (RGA)	24
11.0	Cost Estimate, by KMCS	25

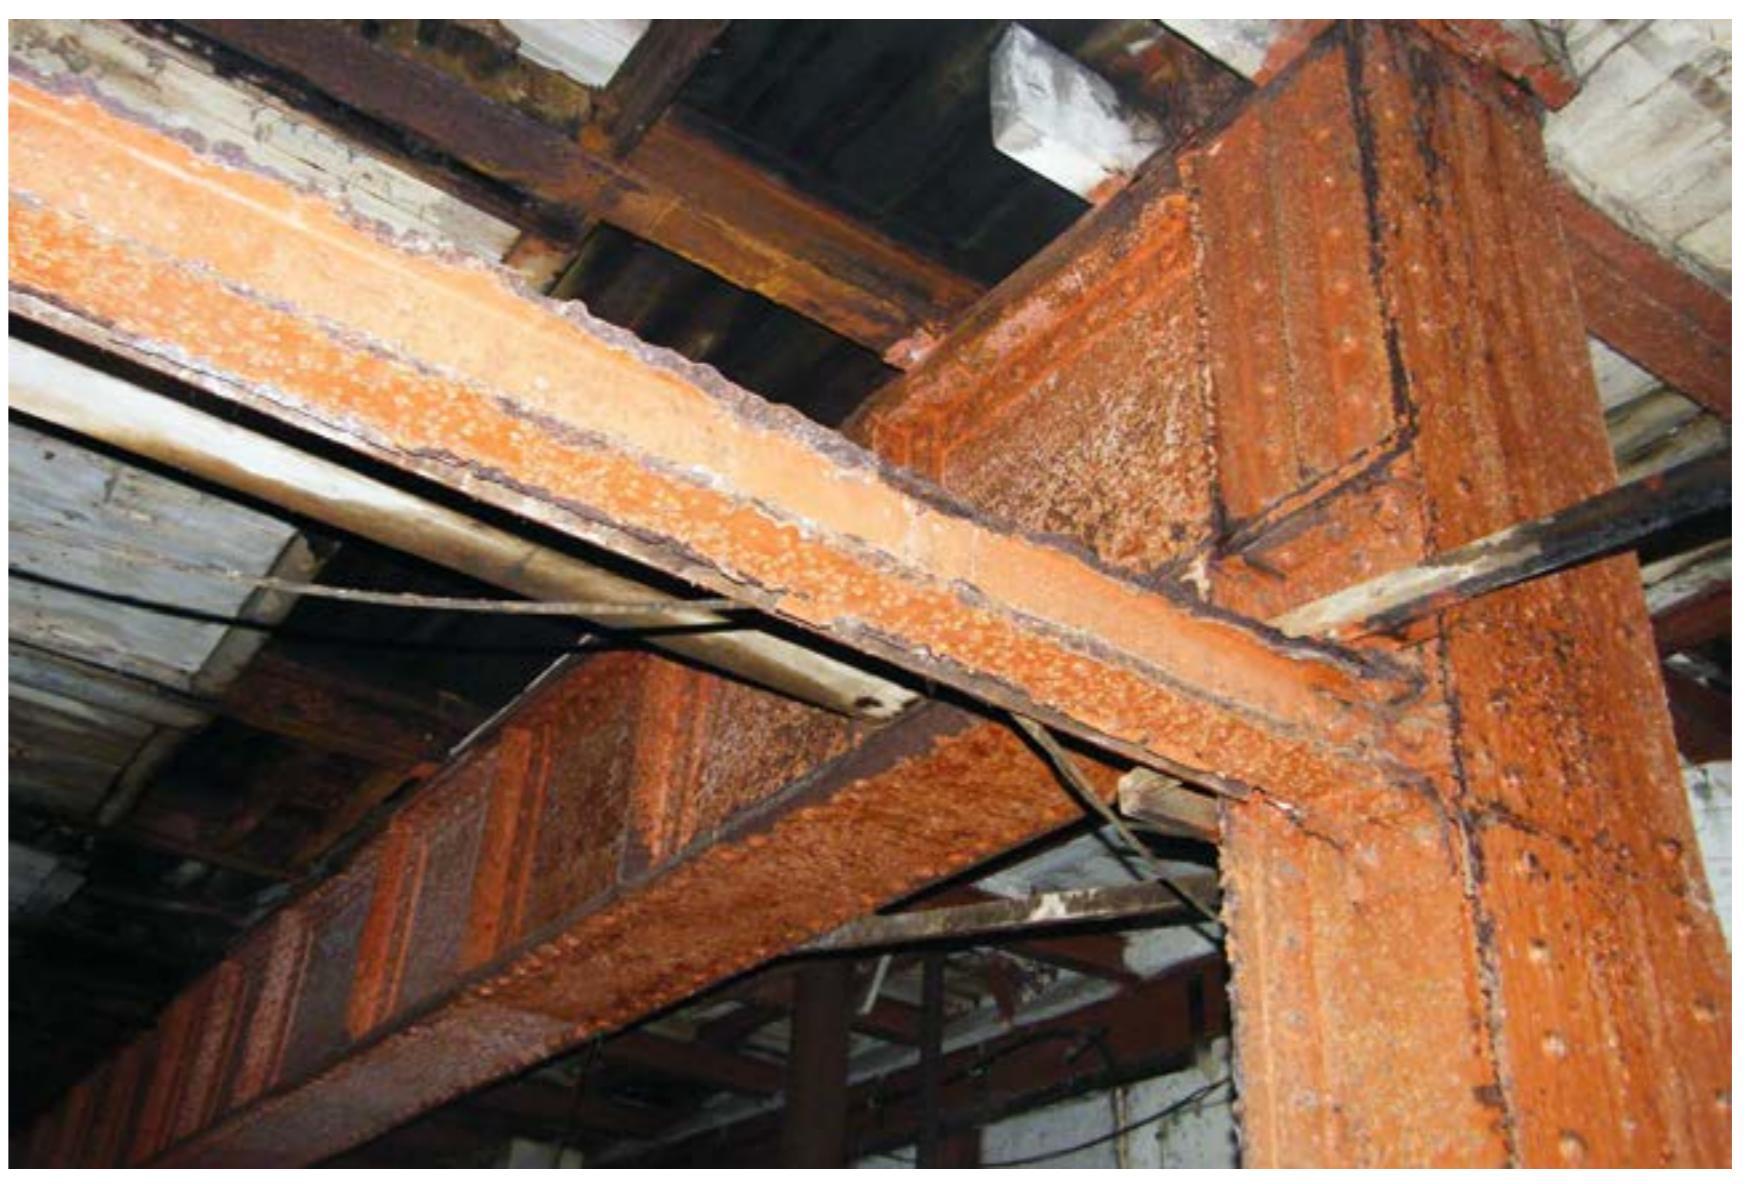
Surface corrosion and impact damage to steel beams

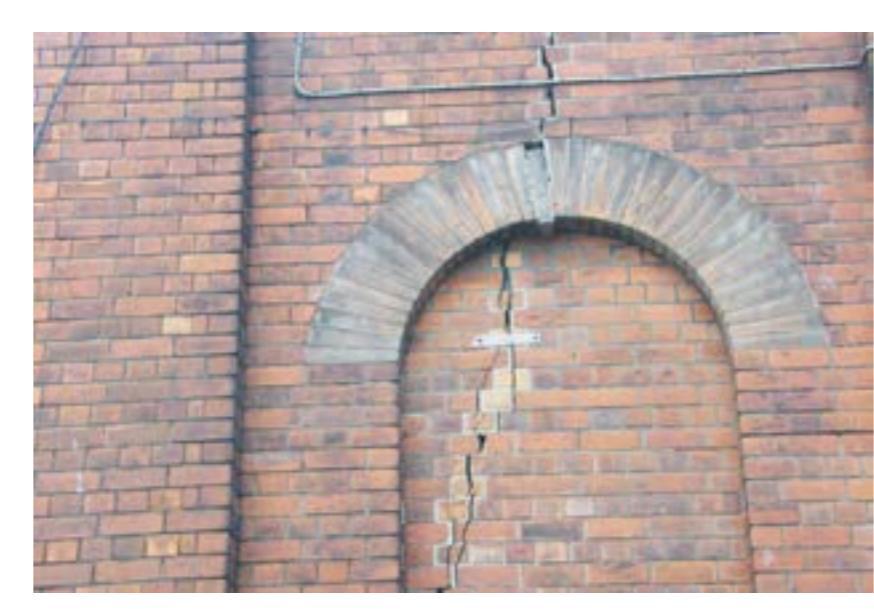
The one area where the cracks in the walls may be related to differential settlement of the foundations is the north western end of the 1907/1910 building where there is a crack almost full height of the walls, and appears to be wider at the top than at the bottom. This is in the corner of the Ice Store.

Cracked brickwork in Ice Store

All the cracks in the brickwork need to be made good by carefully cutting out the cracked bricks and stitching in new brickwork. Where the cracks extend full width through the brickwork, this needs to be done from both sides (inside and outside).

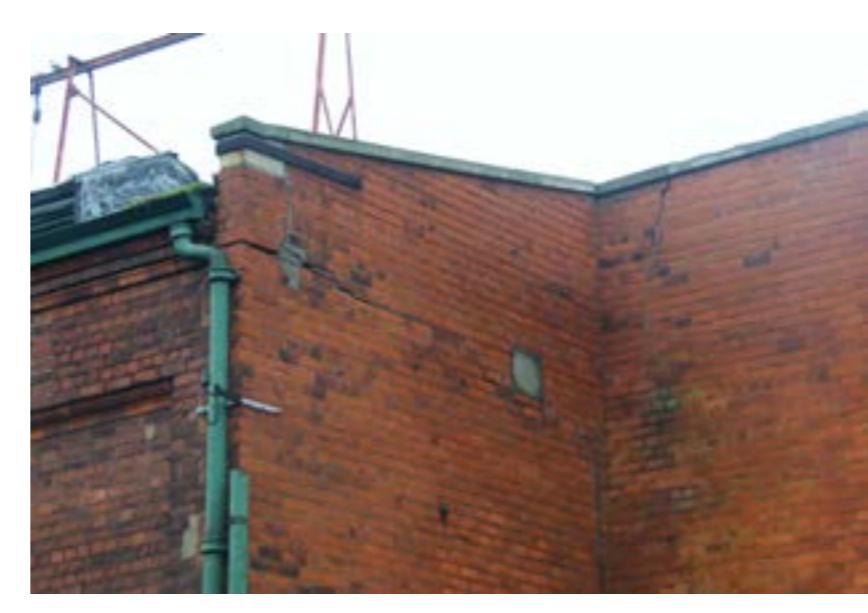
Cracks in parapet walls

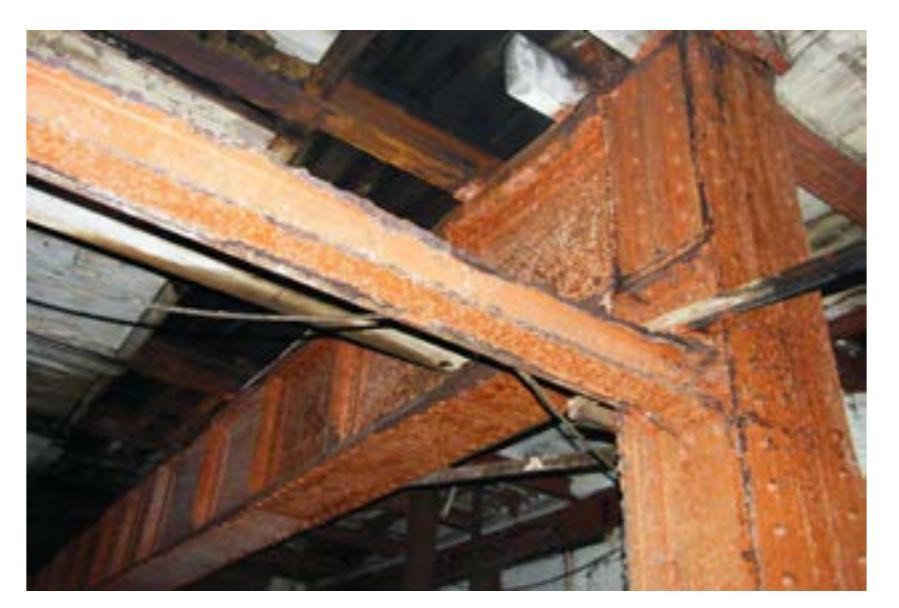
Physical and corrosion damage to steelwork

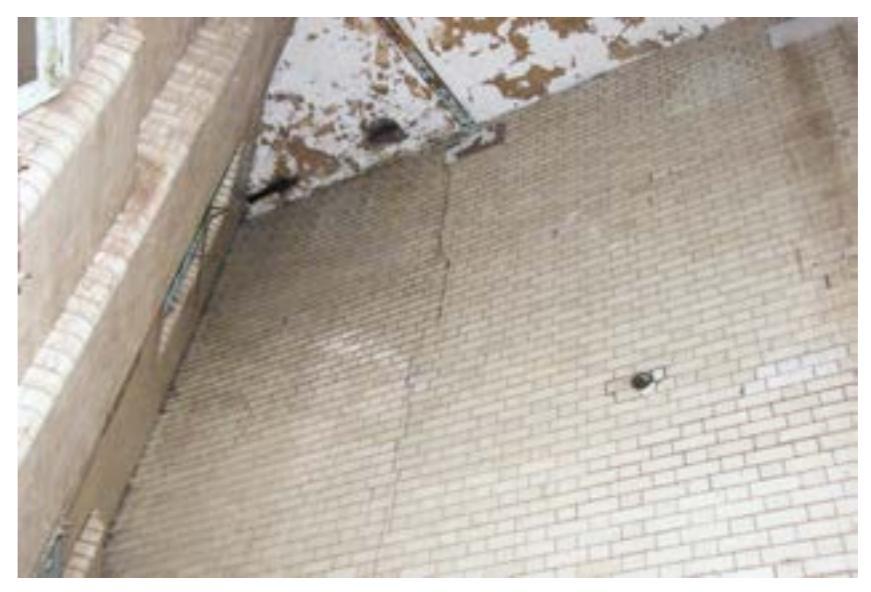
Cracked brickwork in Compressor Room

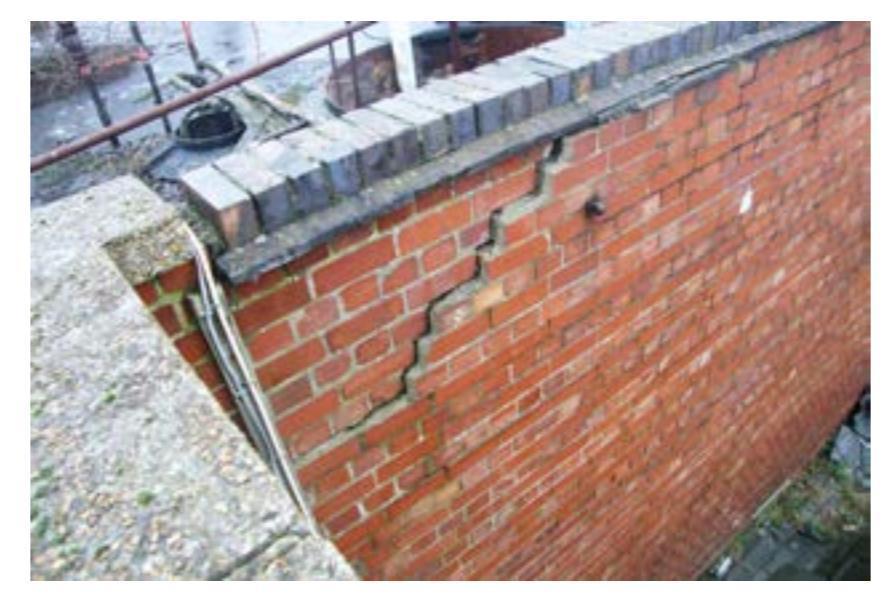
Crack in parapet to roof over Ice Store

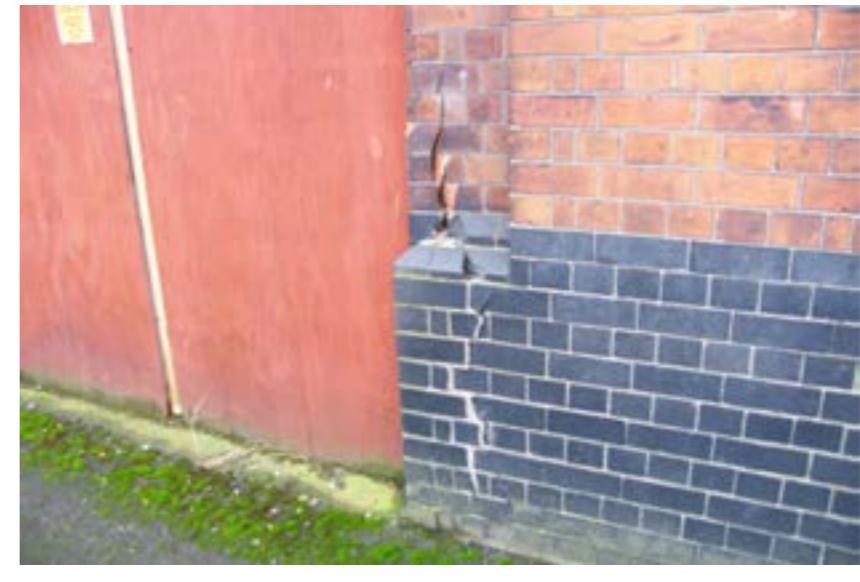
Impact damage to brickwork around opening in wall

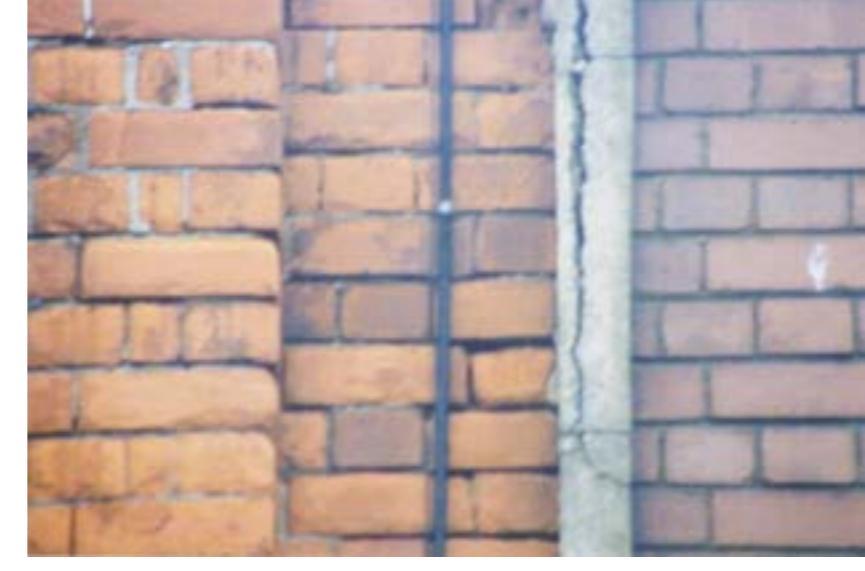
Cracked concrete where reinforcement is corroding

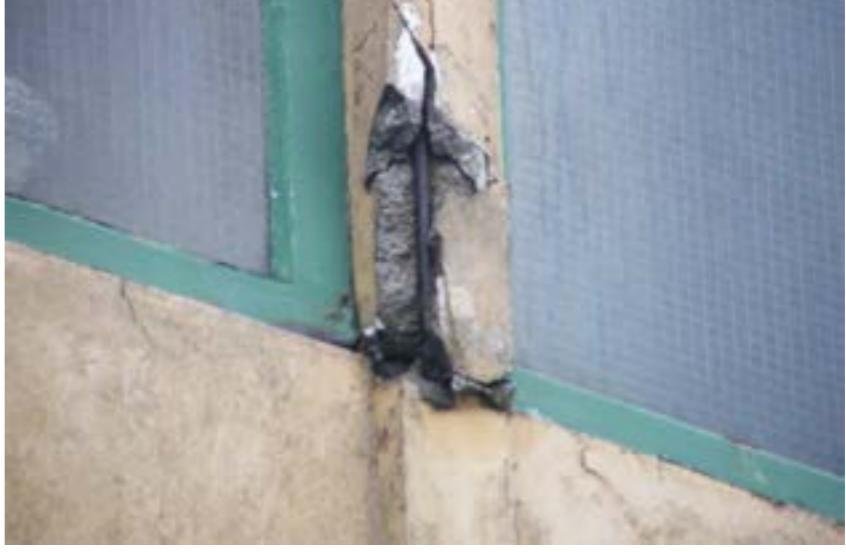
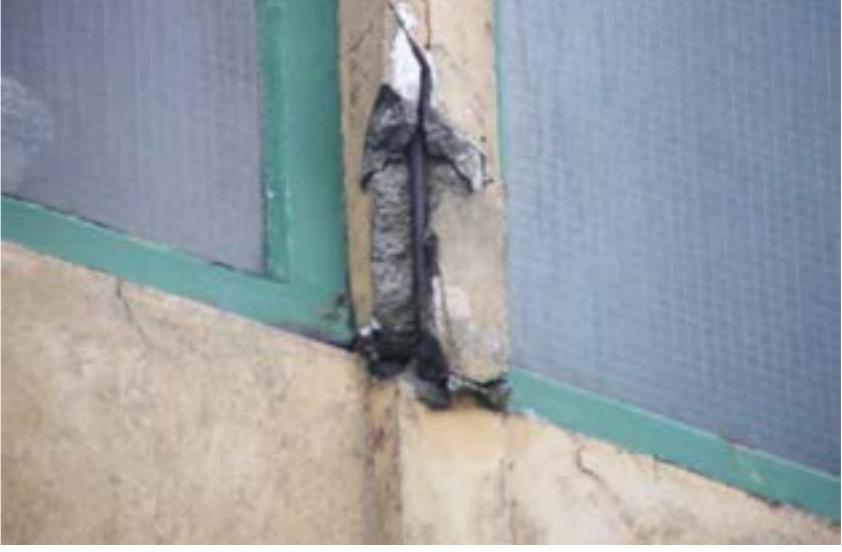
Spalled concrete as a result of corroded reinforcement

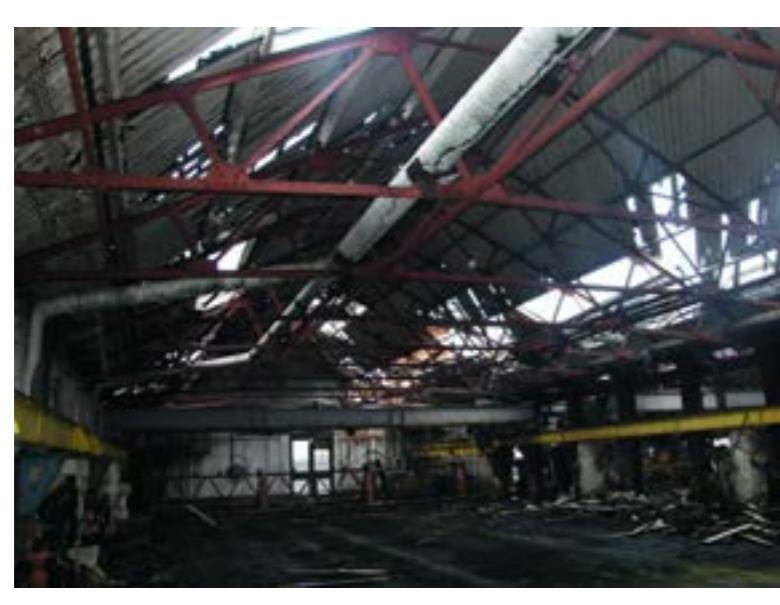
- 6.7.1 Generally the timber boarding and purlins to the pitched roofs to the original tank rooms and boiler house appear to be in a poor state as a result of prolonged rainwater penetration. The steel trusses, however, seem to be in a reasonable condition though it would be prudent to expect to find some local problems to do with corrosion especially along the valley gutter to the original building.
- 6.7.2 The timber trusses to the ice store in the 1907/1910 building are likely to have been much more affected by rainwater penetration than the steel trusses and so we would expect to find some extensive wet and perhaps dry rot especially in the ends of the trusses along the valley gutters and around the edge of the building under the parapet gutter.

Roof to original Tank Rooms

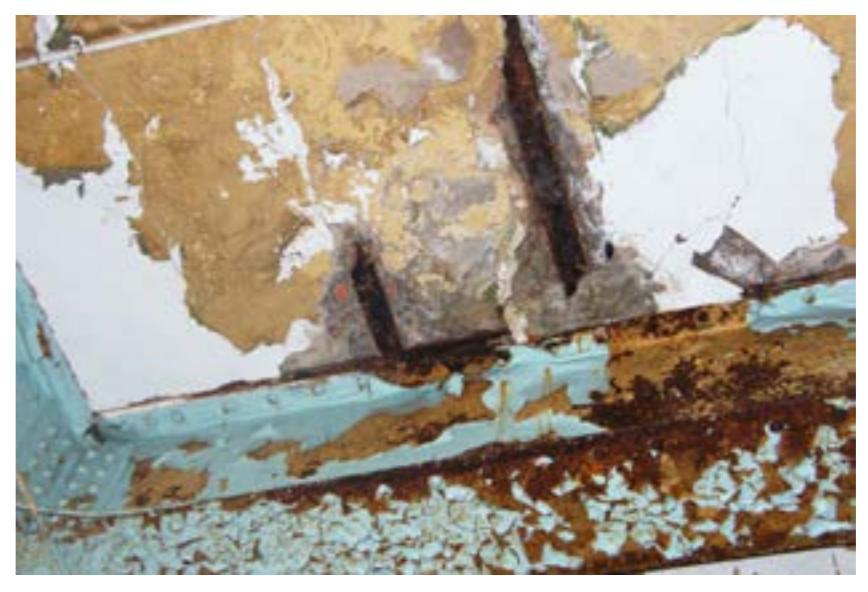
Severely corroded steel joist in flat roof

6.7.5 All of the other flat roofs appear to be of filler joist construction and in several areas the concrete cover to the bottom of the steel joists has spalled exposing corroded steelwork. This is evident in the compressor room, ice store and condenser room roofs in the original building. We suspect this is also the case in the roofs to the loading

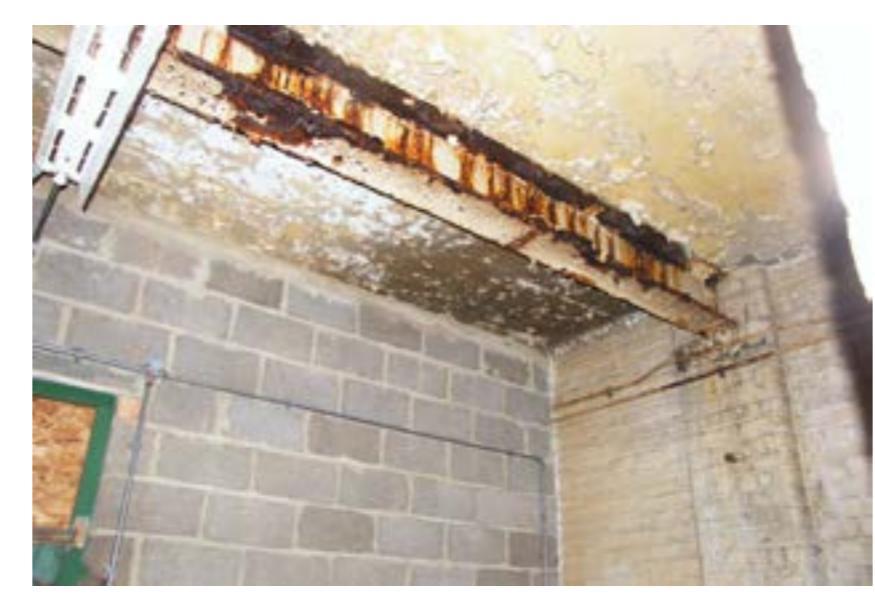
Rainwater penetration over many years has led to some significant corrosion of the steel beams to the first floor in the office. The steel joists to the filler joist floor are also likely to be affected.

First floor to 1950s Office

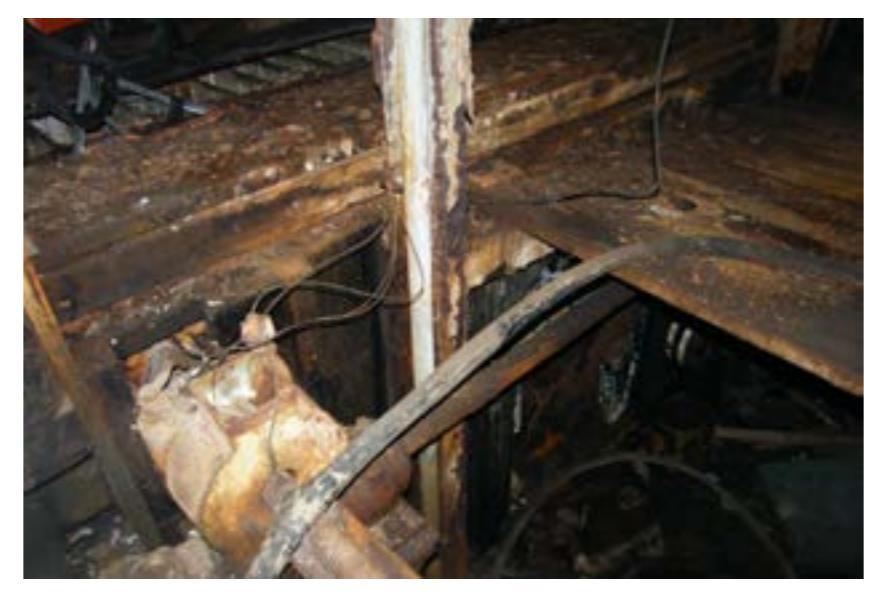
No access was possible to the undercroft, as it was mostly filled with water, but from what could be seen from the entrance, the steelwork at this level is in an extremely poor state. Only a few beams and columns were visible and these were severely corroded and delaminating to such an extent that in places the flange and parts of the web of the beams and columns were missing.

Severely corroded steel column in Tank Room undercroft

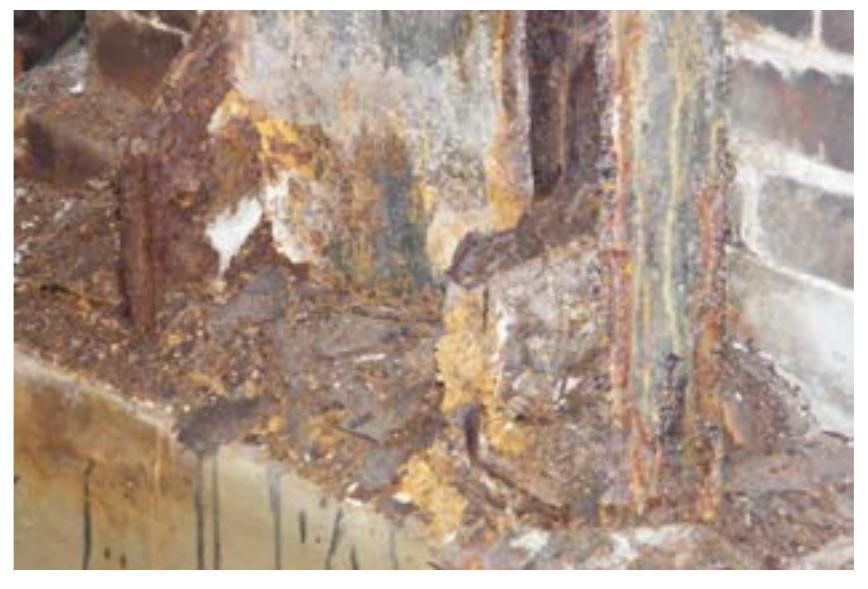
The steel columns supporting the roof and first floor have heavily gusseted bases where they are fixed to the top of the ground slab, which is thickened at each column position and must also be the foundation to the column. The steelwork column is covered in surface corrosion, but at their base the column and gusset plates are severely corroded and delaminating in places.

Corrosion to bottom of Columns in 1907/1910 Tank Room

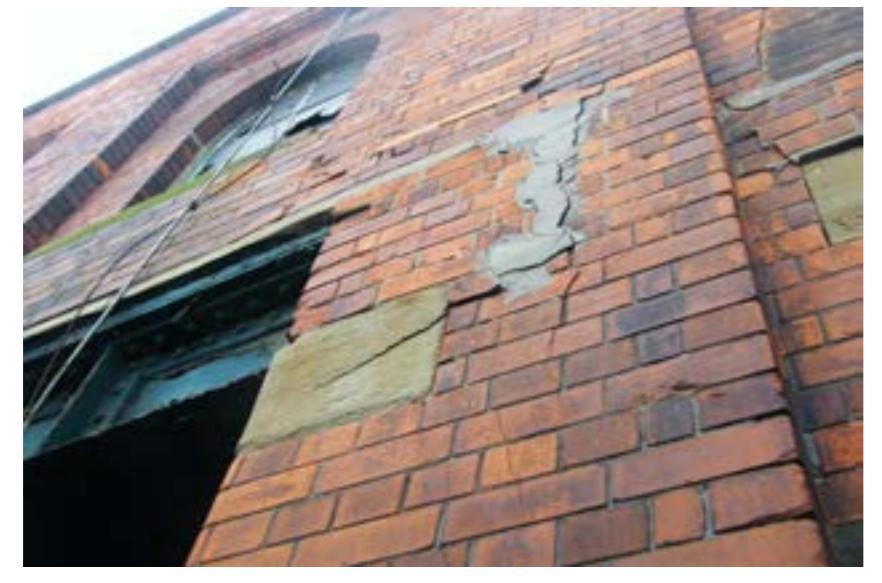
Cracks in brickwork where steel beam is severely corroded

Where the cracks are the result of corroded steelwork the cause of the cracking, ie the expansion of the steelwork as it corrodes and delaminates, also needs to be addressed. This involves carefully removing the brickwork around the embedded steelwork (eg beam end), introducing temporary supports to the steelwork where needed, so that the steelwork can be thoroughly wire brushed to remove all loose rust, cleaned, and then painted with two coats of bituminous paint, prior to making good the brickwork around the steel as above. In some locations the steelwork may be found to also need some repair and so a contingency should be allowed to cover this too.
