Ice Factory, Grimsby Appraisal of Existing Structure by Alan Baxter & Associates LLP with Richard Griffiths Architects and KMCS (Cost Consultant) February 2010

1.0	Summary	1
2.0	Introduction	2
3.0	History of the Building and the Site	3
4.0	Geology	5
5.0	Form of Existing Structure	7
6.0	Obvious Defects in the Existing Structure	13
7.0	Proposals for Remedial Works to the Existing Structure	19
8.0	Proposed Alterations to the Structure	22
9.0	Next Stage	23
10.0	Existing Fabric, by Richard Griffiths Architects (RGA)	24
11.0	Cost Estimate, by KMCS	25

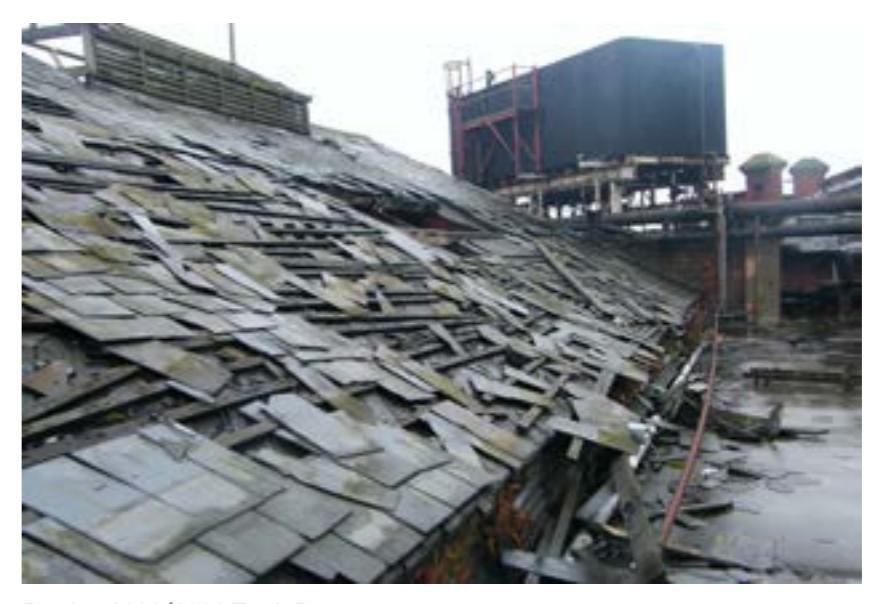
Roof to 1900/1901 Tank Room

- 6.7.1 Generally the timber boarding and purlins to the pitched roofs to the original tank rooms and boiler house appear to be in a poor state as a result of prolonged rainwater penetration. The steel trusses, however, seem to be in a reasonable condition though it would be prudent to expect to find some local problems to do with corrosion especially along the valley gutter to the original building.
- 6.7.2 The timber trusses to the ice store in the 1907/1910 building are likely to have been much more affected by rainwater penetration than the steel trusses and so we would expect to find some extensive wet and perhaps dry rot especially in the ends of the trusses along the valley gutters and around the edge of the building under the parapet gutter.

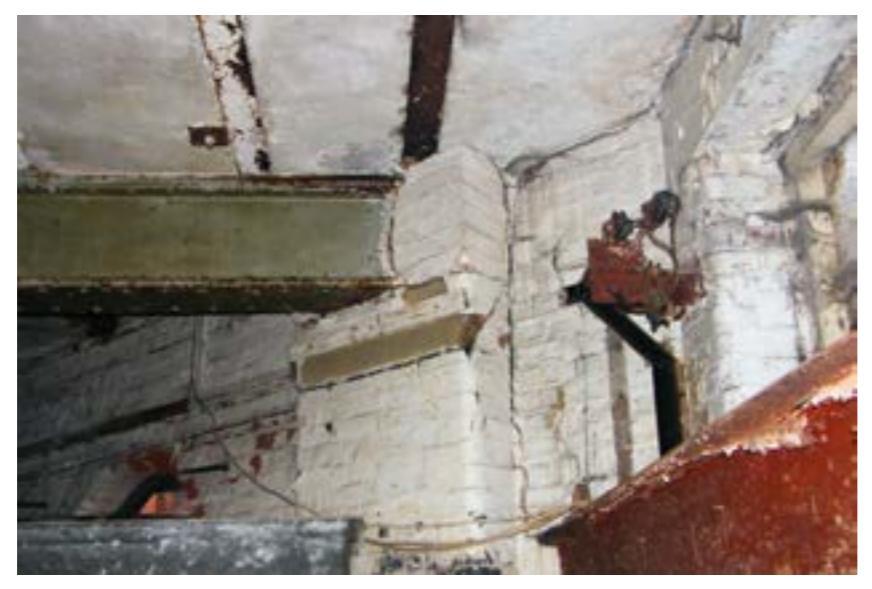
Roof beam and filler joist roof by 1900/1901 Ice Store

6.7.5 All of the other flat roofs appear to be of filler joist construction and in several areas the concrete cover to the bottom of the steel joists has spalled exposing corroded steelwork. This is evident in the compressor room, ice store and condenser room roofs in the original building. We suspect this is also the case in the roofs to the loading

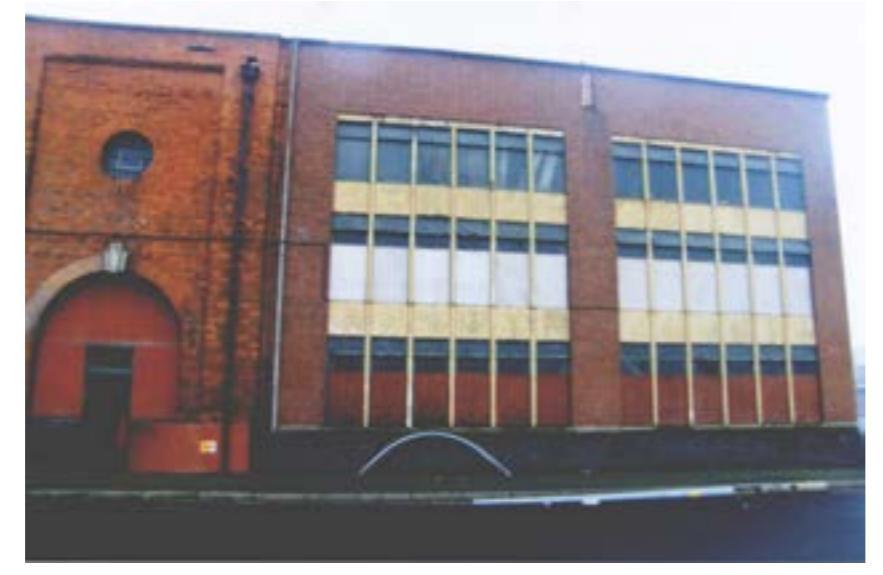
- 6.6.2 Refer to the Architect's drawings for non-structural issues such as minor cracks, weathering etc.
- 6.6.3 The reinforced concrete window frame in the 1950s office and condenser rooms is in a poor condition with spalling of the concrete in several areas as a result of prolonged rainwater penetration of the concrete causing the reinforcement to corrode, expand and push off the concrete.

RC frame around windows in 1950s extension

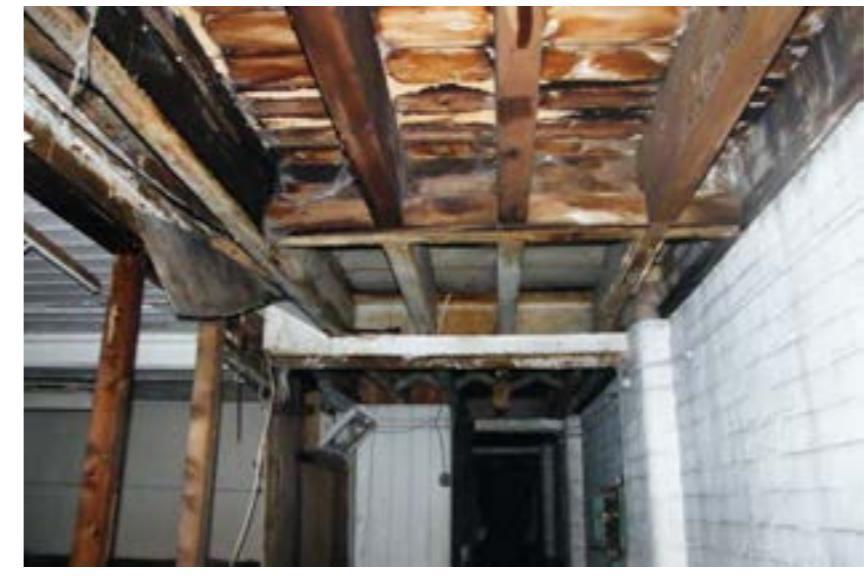
- 6.7.3 The timber structure to the shallow pitched roof over the office in the 1950s extension is likely to be in a very poor condition and some of the supporting steel beams also appear to be significantly corroded.
- 6.7.4 We noted some spalling of concrete locally in some areas of the underside of the reinforced concrete roof to the compressor room in the 1950s extension suggesting rainwater has been penetrating the roof finishes and the slab for many years. It is likely that there will be other areas where the reinforcement is corroded especially in the top of the slab.
- bay in the 1907/1910 extension.

Roof to 1950s Office

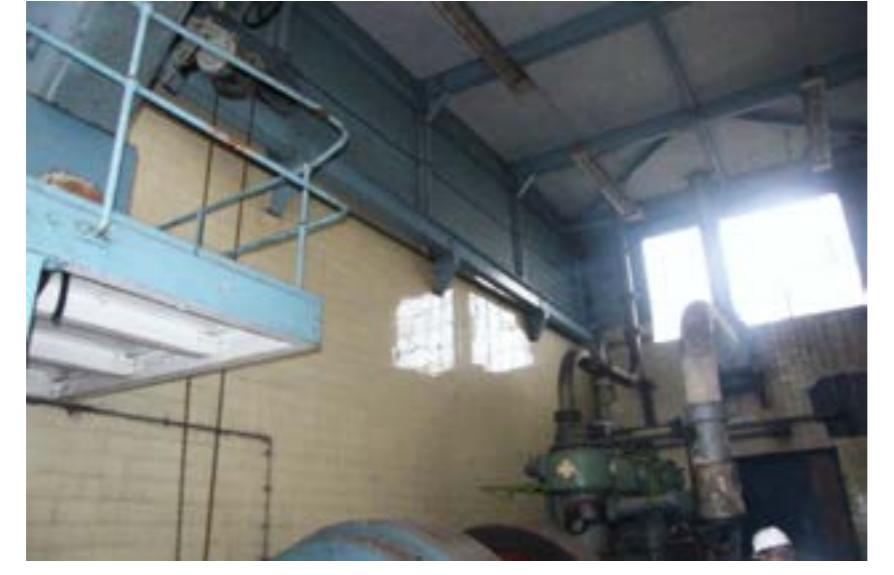
1950s Compressor Room

Elsewhere in the compressor rooms the internal steel structure generally appears to suffer from some surface corrosion only, which is not of major structural significance.

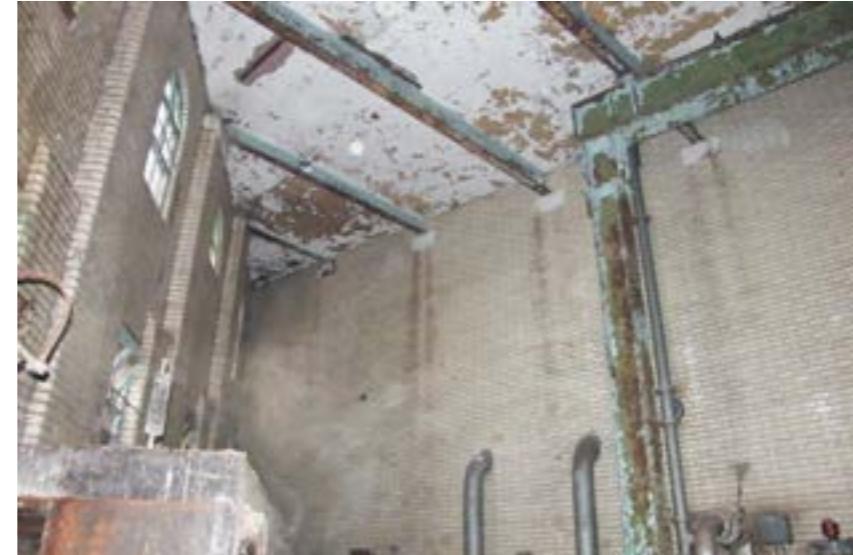
**Original Compressor Room**

Severely corroded steel joist in flat roof

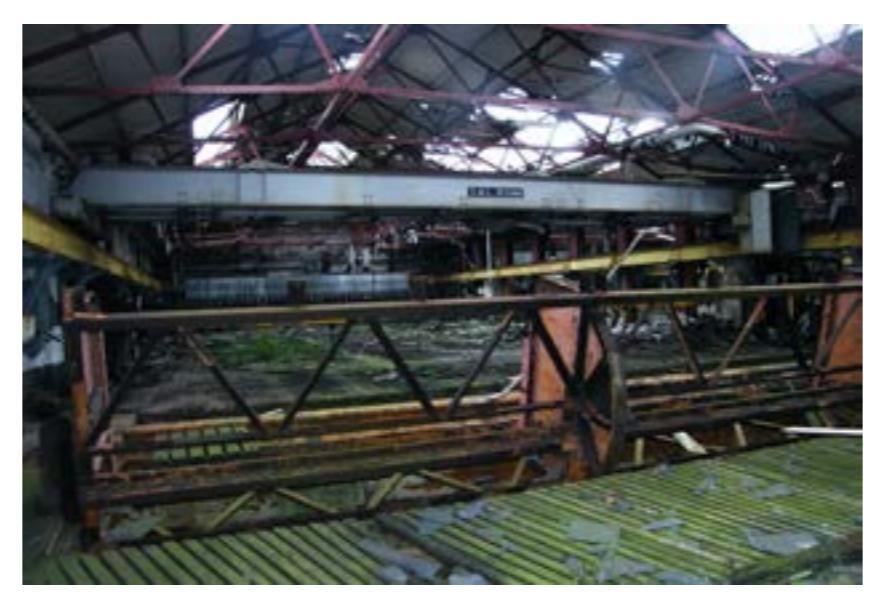
First floor Tank Room

The steel structure above first floor level generally appears to be in a poor condition as a result of the prolonged rainwater penetration through the building. At this level the most obvious defect is surface corrosion of the steelwork and this varies considerably with only local areas that appear to be significant.

Whilst very limited access was possible across this area of the building, it appears that at first floor level (ie the upper ice making level), the effect of the rainwater and the aggressive environment during the ice making process has left the timber boarded floor in a very poor state and both the extent and severity of corrosion of the steel framed structure is much more serious than above.

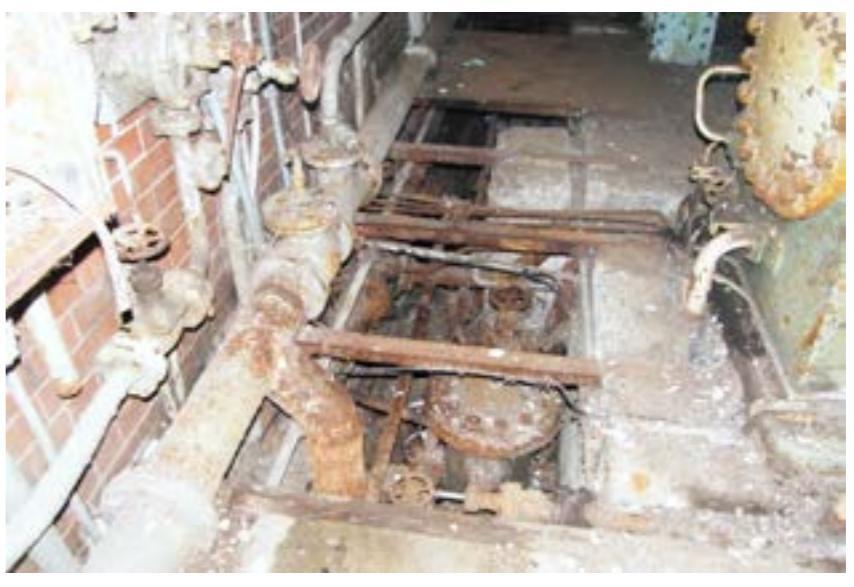
Services trench in Compressor Room ground floor

The ground floor contains three trenches which were about half full of water during our visit in January. We suspect the reinforced concrete is not in a good condition.

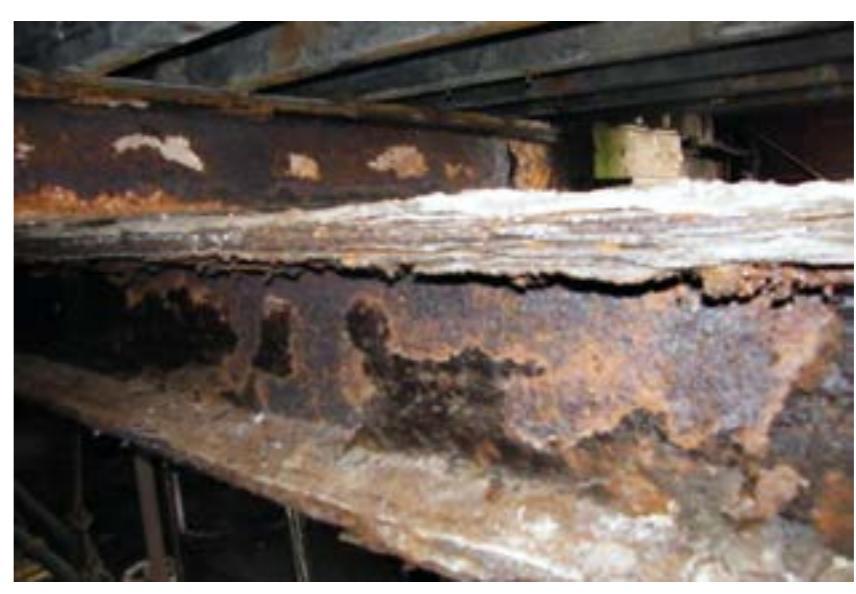
No access was possible to the undercroft, as it was mostly filled with water, but from what could be seen from the entrance, the steelwork at this level is in an extremely poor state. Only a few beams and columns were visible and these were severely corroded and delaminating to such an extent that in places the flange and parts of the web of the beams and columns were missing.

Severely delaminating steel beam in Tank Room undercroft

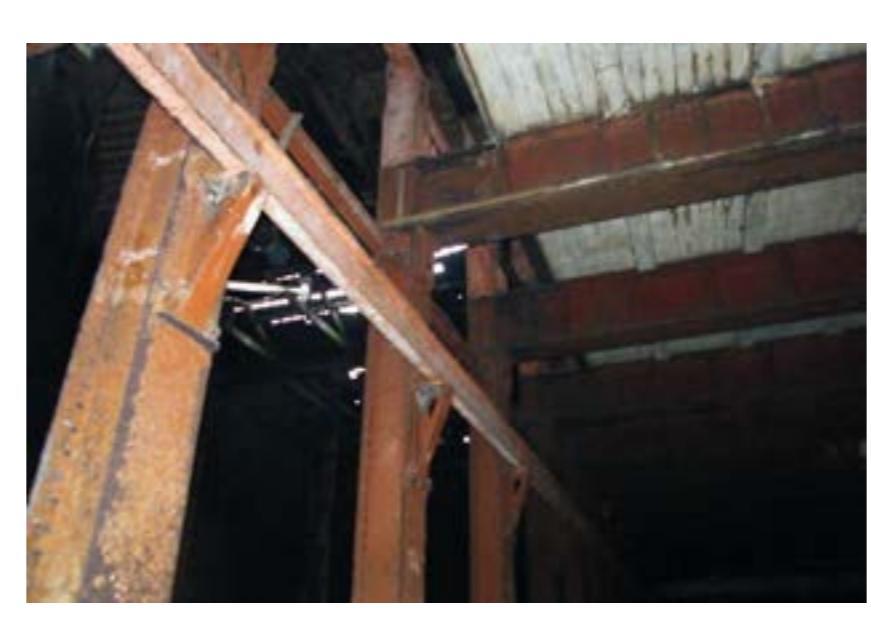
First floor to Ice Store 1900/1901

The timber and steel framed structure supporting the first floor has suffered from rainwater penetration and the aggressive conditions within the ice making environment in a similar though seemingly not as severely as in the original tank rooms 6.8.2 above.

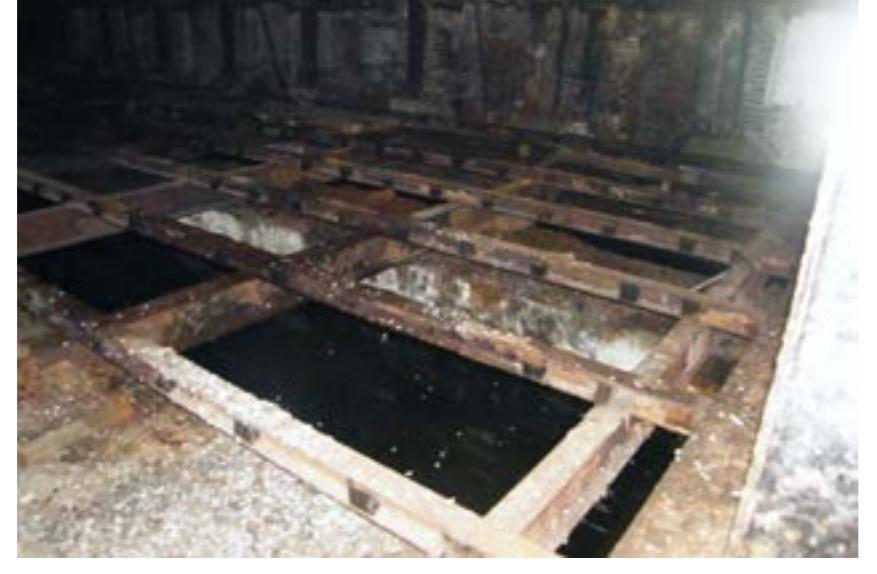
U/s first floor to Tank Room 1907/1910

Local areas of the timber boarded first floor and the steel beam supports have suffered as a result of their prolonged wet state and in places the timber is close to collapse. There is extensive surface corrosion in the steel beams.

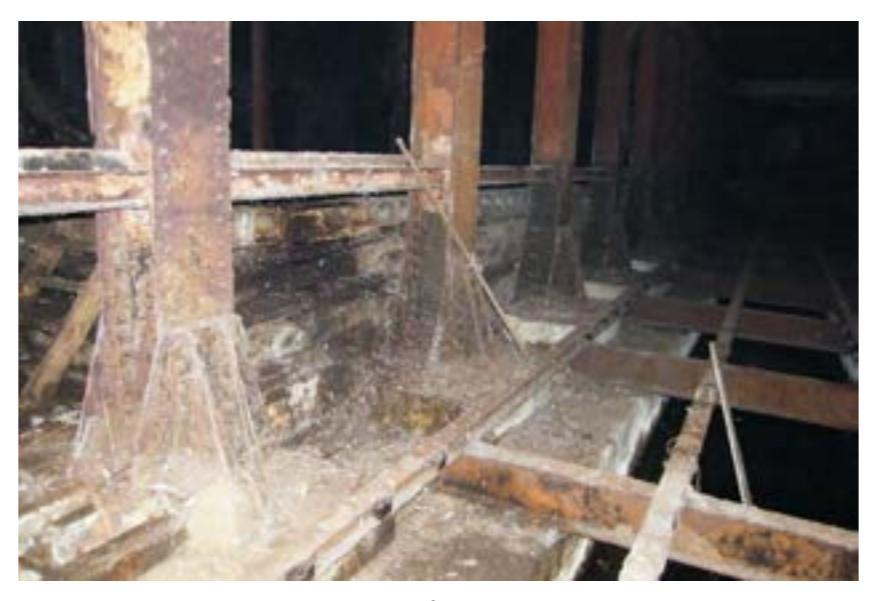
The steel columns supporting the roof and first floor have heavily gusseted bases where they are fixed to the top of the ground slab, which is thickened at each column position and must also be the foundation to the column. The steelwork column is covered in surface corrosion, but at their base the column and gusset plates are severely corroded and delaminating in places.

Gurretted bases to Columns in 1907/1910 Tank Room

- (ii) Clear out all the debris etc.
- (iii) Remove all rotten/damaged timber boarding.
- (iv) Pump out all the water from the trenches and undercrofts.
- (v) Where steel columns have become significantly affected by corrosion/delamination these should either be replaced, or perhaps encased in reinforced concrete to maintain their structural function. This applies to some if not all of the columns in the undercroft beneath the original 1990/1901 tank rooms.
- (vi) The buildings then need to be well ventilated to allow them to dry out. This needs to be done in a controlled and maintained way so that it is not only effective but also avoids further problems being generated such as dry rot manifesting itself in the timber structure.

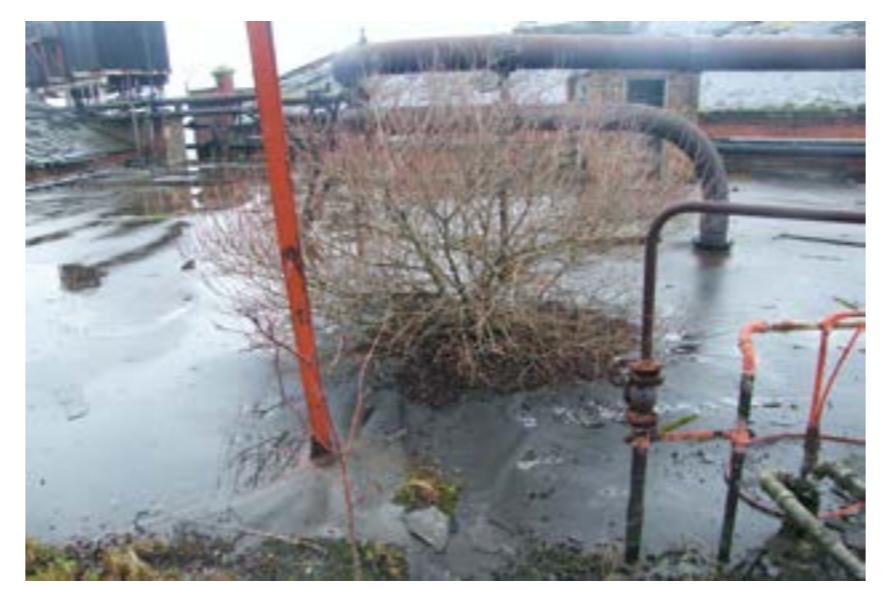
Roof over Ice Store 1900/1901

The longer span pitched roofs over the old boiler house, and the tank rooms (1900/1901 and 1907/1910) generally appear to be in a little better condition than the others. In these areas the timber boarding looks to be in a poor state in places, but elsewhere it may be possible to re-use the boards. Similarly, some of the timber purlins look as if they will need replacing and others look as if they can be retained.

All the roof coverings are removed (see also Architects'

The steel trusses can then be thoroughly wire brushed to remove all surface corrosion and repainted.

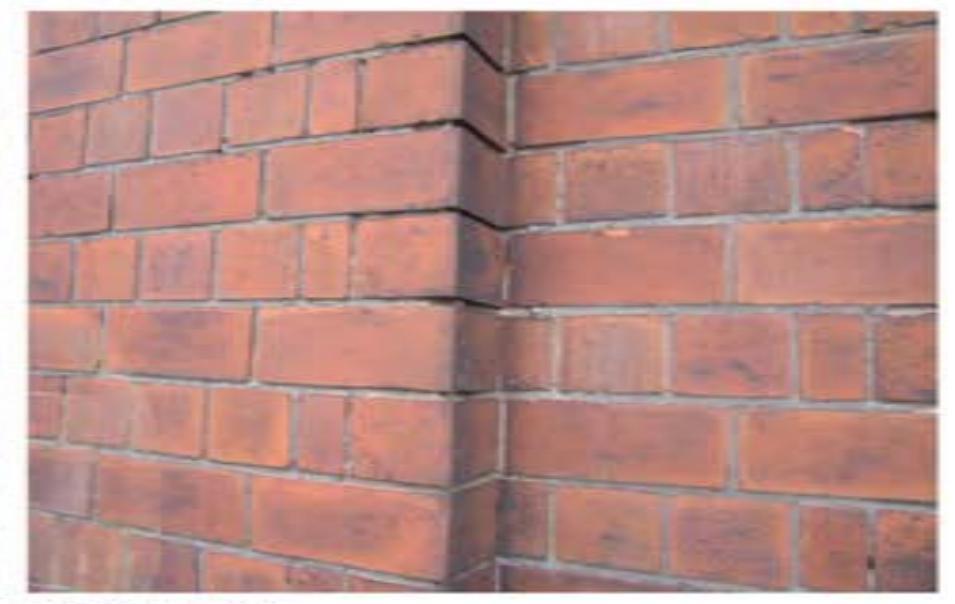
Detail of mortar joints

Given the exposed location of the site, the nature of the original brickwork and the size of the buildings, we would recommend the use of a pre-mixed naturally hydraulic lime mortar, which can be supplied to site in a silo. The use of cement-based mortars in repairs would be very damaging to the saturated brickwork, causing long term failure of the bricks through the migration of salts to the surface. Modern hydraulic lime mortars are closer to historic cement mortars in chemical composition than modern Portland cement and therefore more suitable for repairs and repointing.

As highlighted above, given the size of the buildings, traditional methods of hand raking-out and repointing are unlikely to be affordable. Specialist mechanical cutters are now available to assist in cutting-out; re-pointing can be carried out through mechanical injection. Such methods have been assumed in the cost estimates but will need to be subject to samples approved by English Heritage in advance. It is important to engage an experienced contractor for this work because poorly executed work could

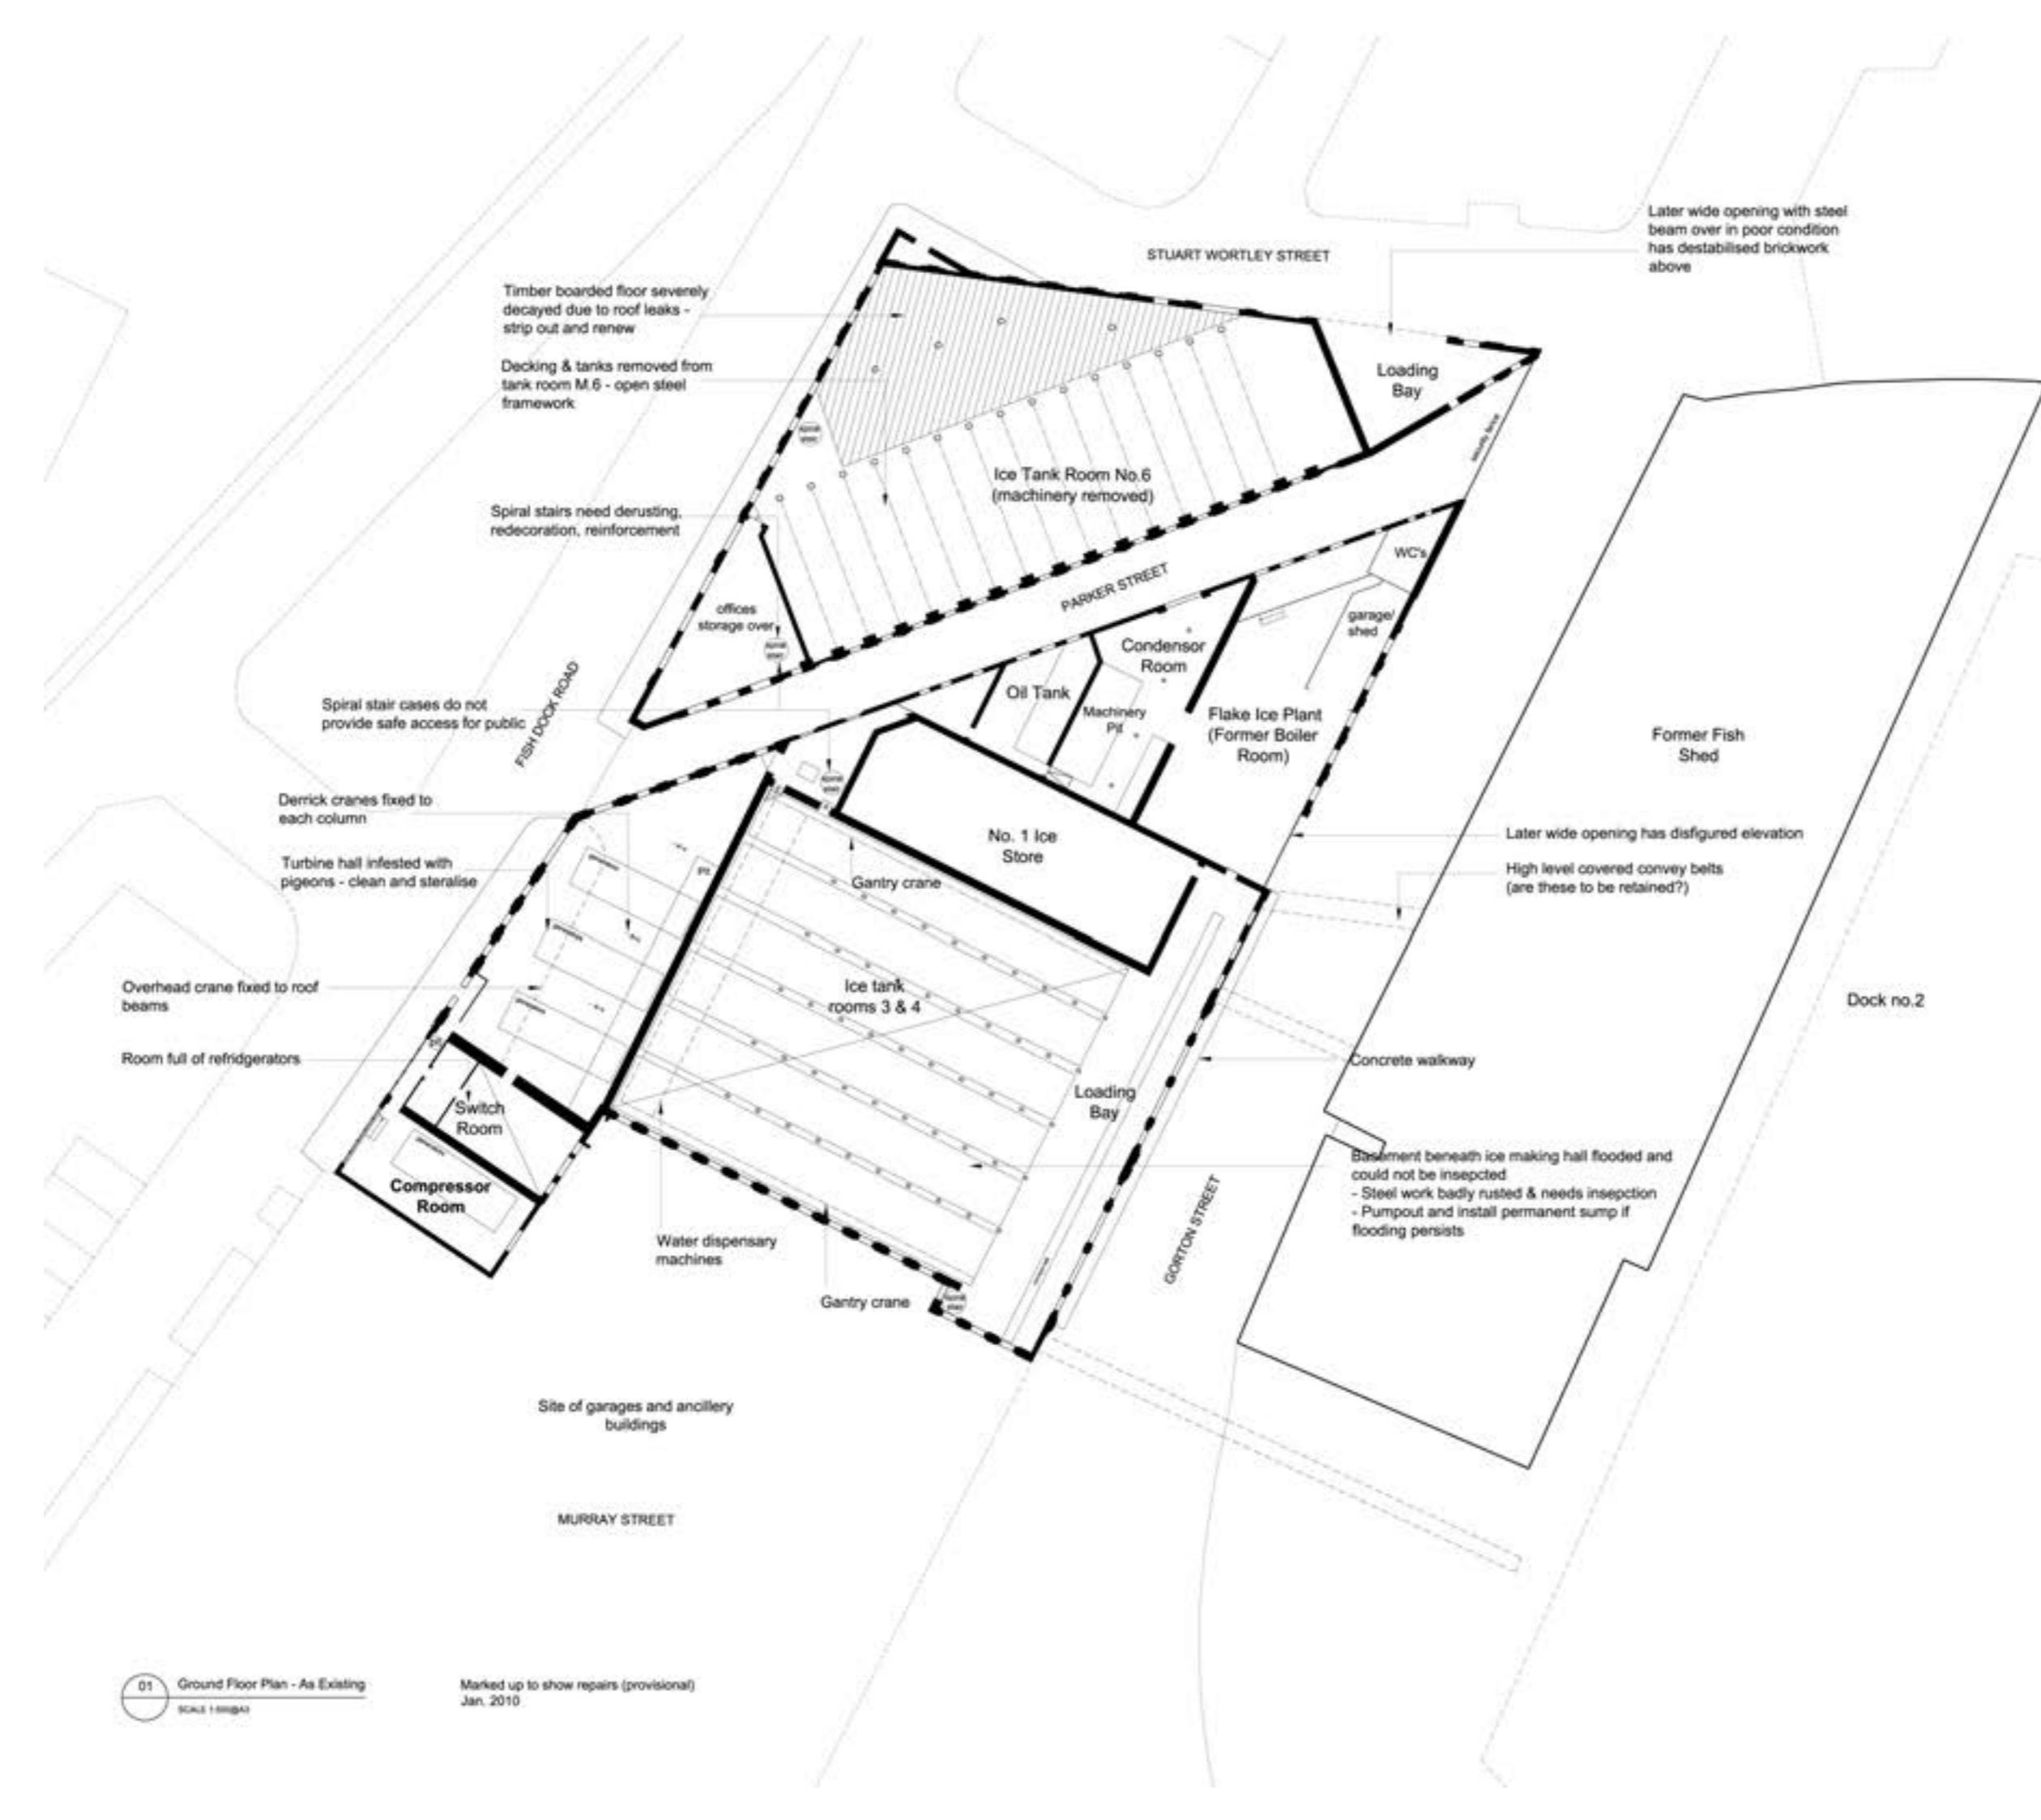
- Safe access for public not available at present •
- Interiors on very large scale
  Most areas affected by water ingress from defective roofs above
- · All turbines, icemaking equiptment, gantry cranes ect, remian insitu
- loe tanks are partly integral with structure
- . Electrical services have not been inspected and need to be made safe.
- All steel structure needs to be inspected by • engineer, reinforced where neccessary, de-rusted
- and redeconated Access platforms and / or mobile platforms required .
- (specialist) All interiors need to dry out over at least two seasons
- All interior surfaces are robust but dirty industrial clean vacuum and high pressure steam (7)

- · Open up (say) 5no. areas to inspect condition of
- structure Assume replacement of 100% finishes and structure .
- Include crash deck beneath .
- Retain and derust principle steel beams Renew filler joist stabs with PCC light weight planks .
- and screed topping . New falls formed in cork/ EPU insulation slabs (min.
- 75mm)
- Renew asphalt and Vistone chippings
